Manhole Inspection Summary

Manhole # S31I2019MH

Location Address: **6002 CHARLESMEAD AVE**

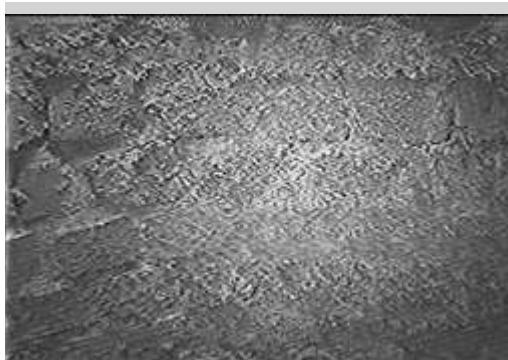
Defect

Bench debris.

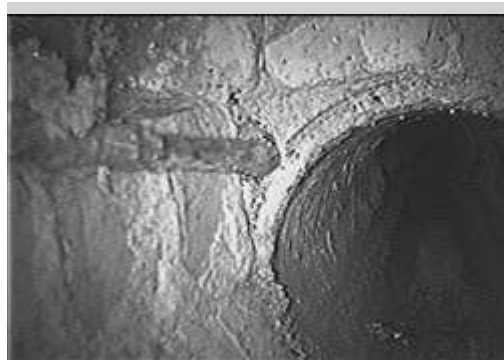
Defect 4

Barrel infiltration.

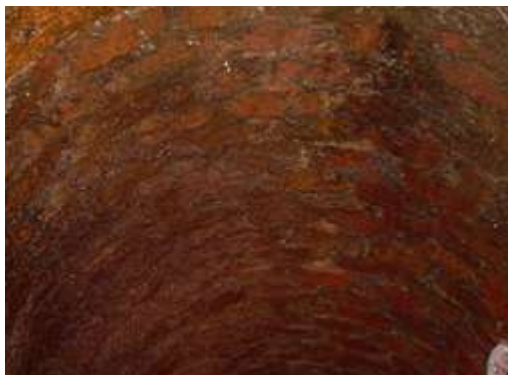
Defect

Root intrusion through I6 Pipe seal.

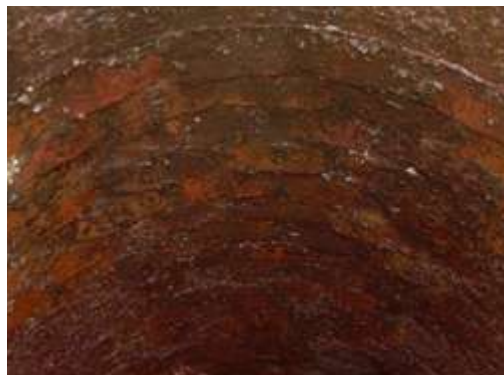
Defect

Adjustment and Corbel infiltration - other side.

Frame leaks. Adjustment and Corbel infiltration.

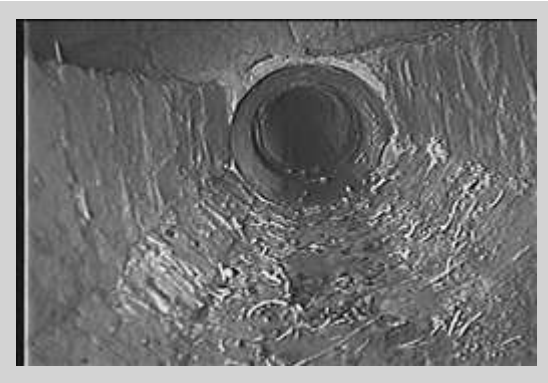
8 in. Circular Gravity Sewer Pipe Out @ 12 O'Clock

Channel deterioration.

Infiltration: **Evidence** Pipe Seal Cond: **Roots**

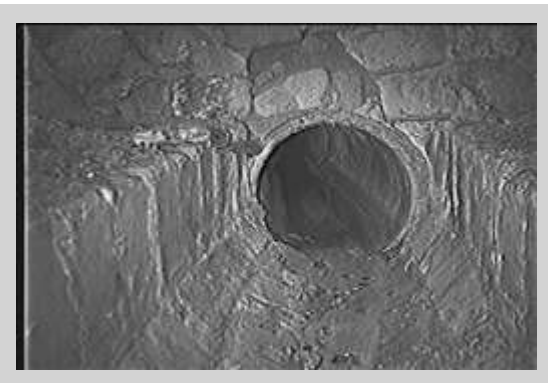
8 in. Circular Gravity Sewer Pipe In @ 6 O'Clock

Infiltration: **Evidence** Pipe Seal Cond: **Roots**
